Debris/Ice/TPS Assessment And Photographic Analysis For Shuttle Mission STS-33R

Charles G. Stevenson
NASA/Kennedy Space Center

DEBRIS/ICE/TPS ASSESSMENT
AND
PHOTOGRAPHIC ANALYSIS
OF
SHUTTLE MISSION STS-33R

November 22, 1989

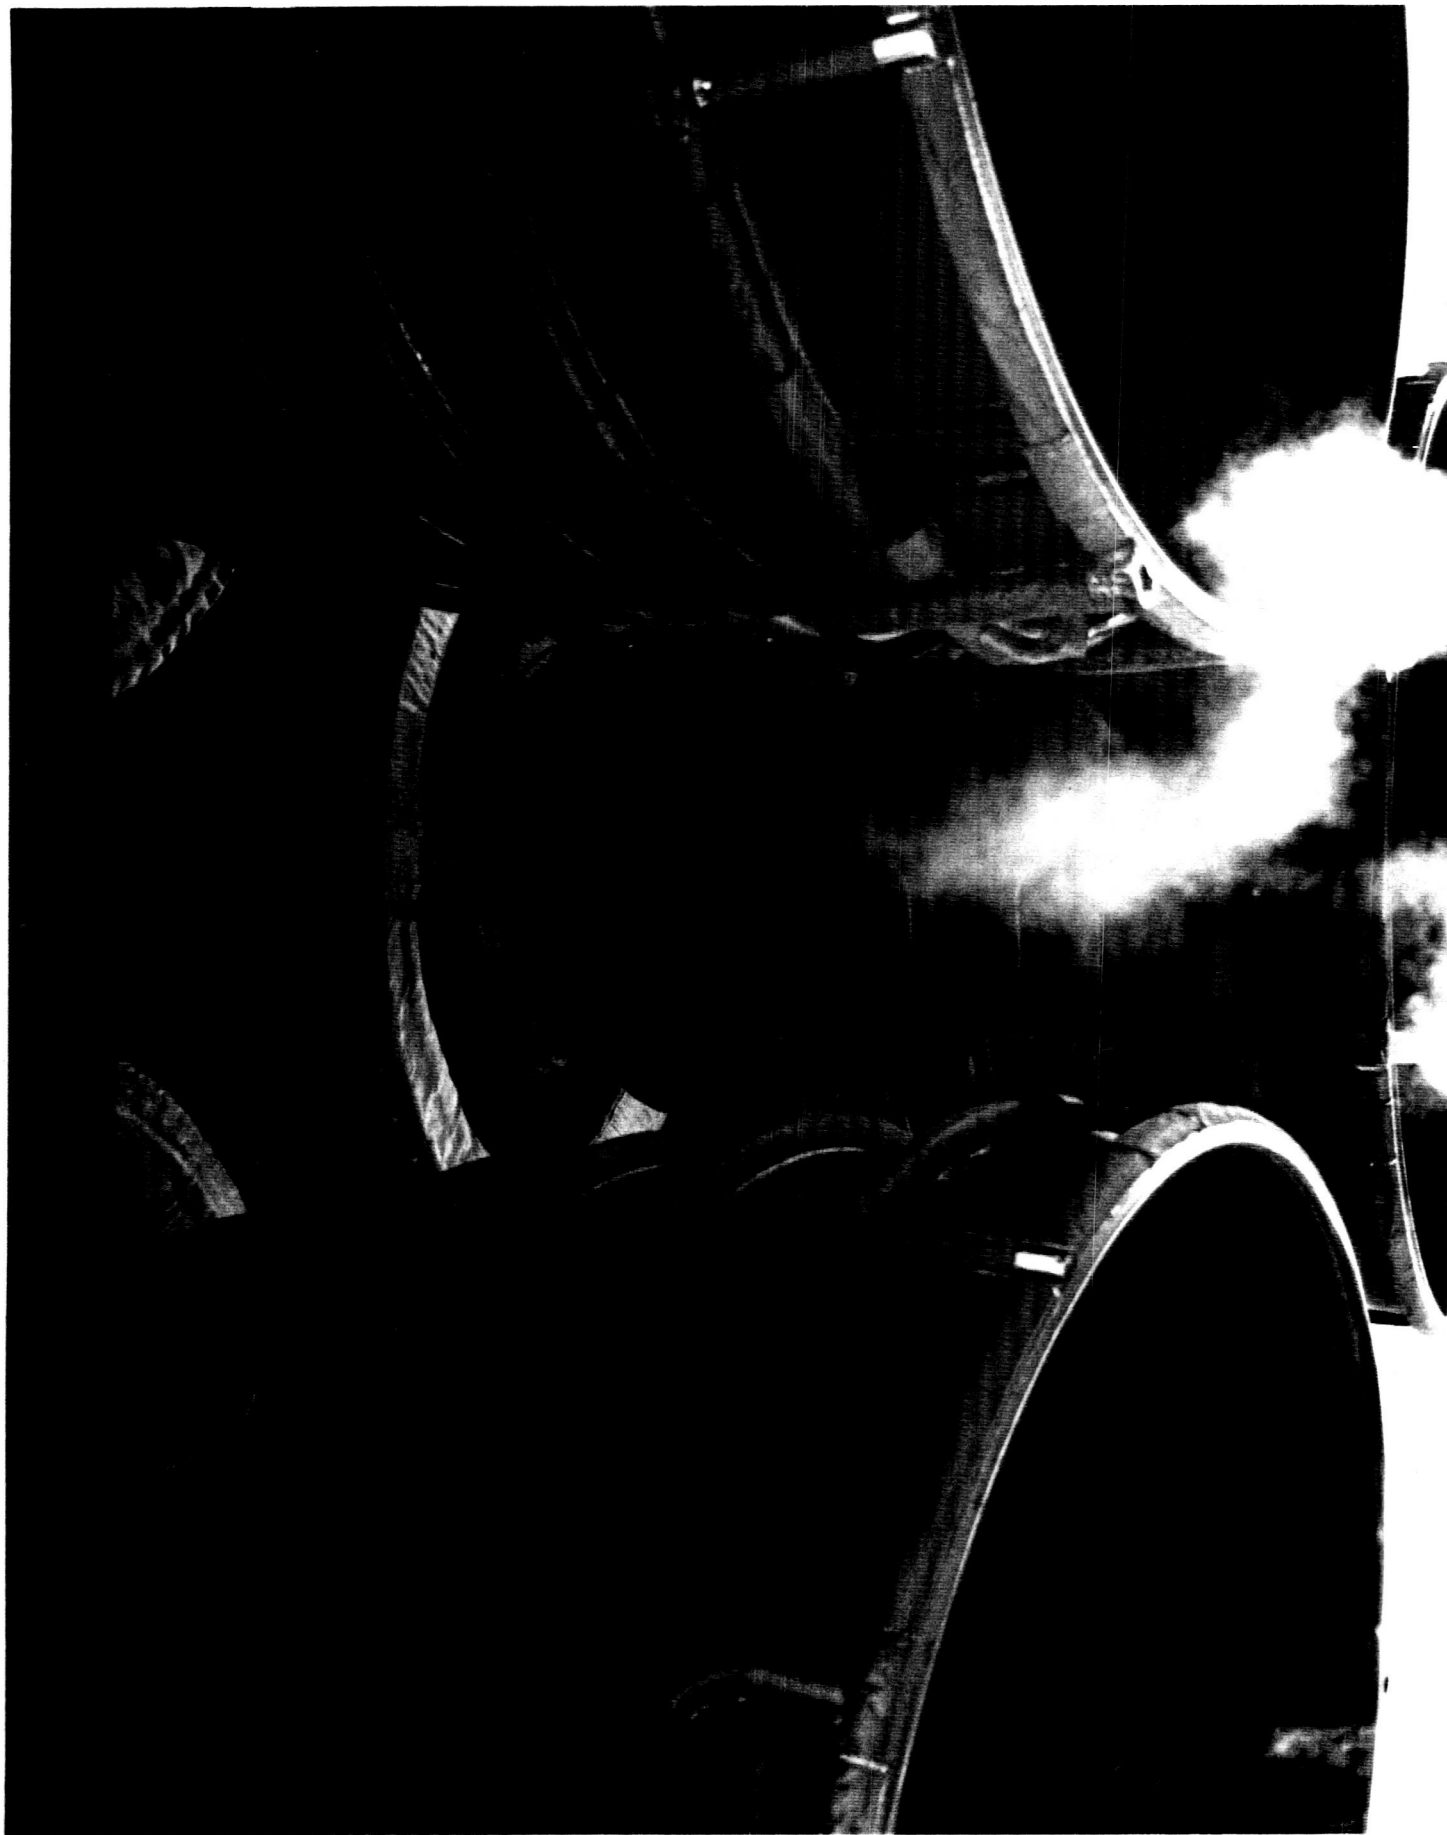
Frost had accumulated on the SSME #1 engine mounted heat shield at the 6 o'clock position

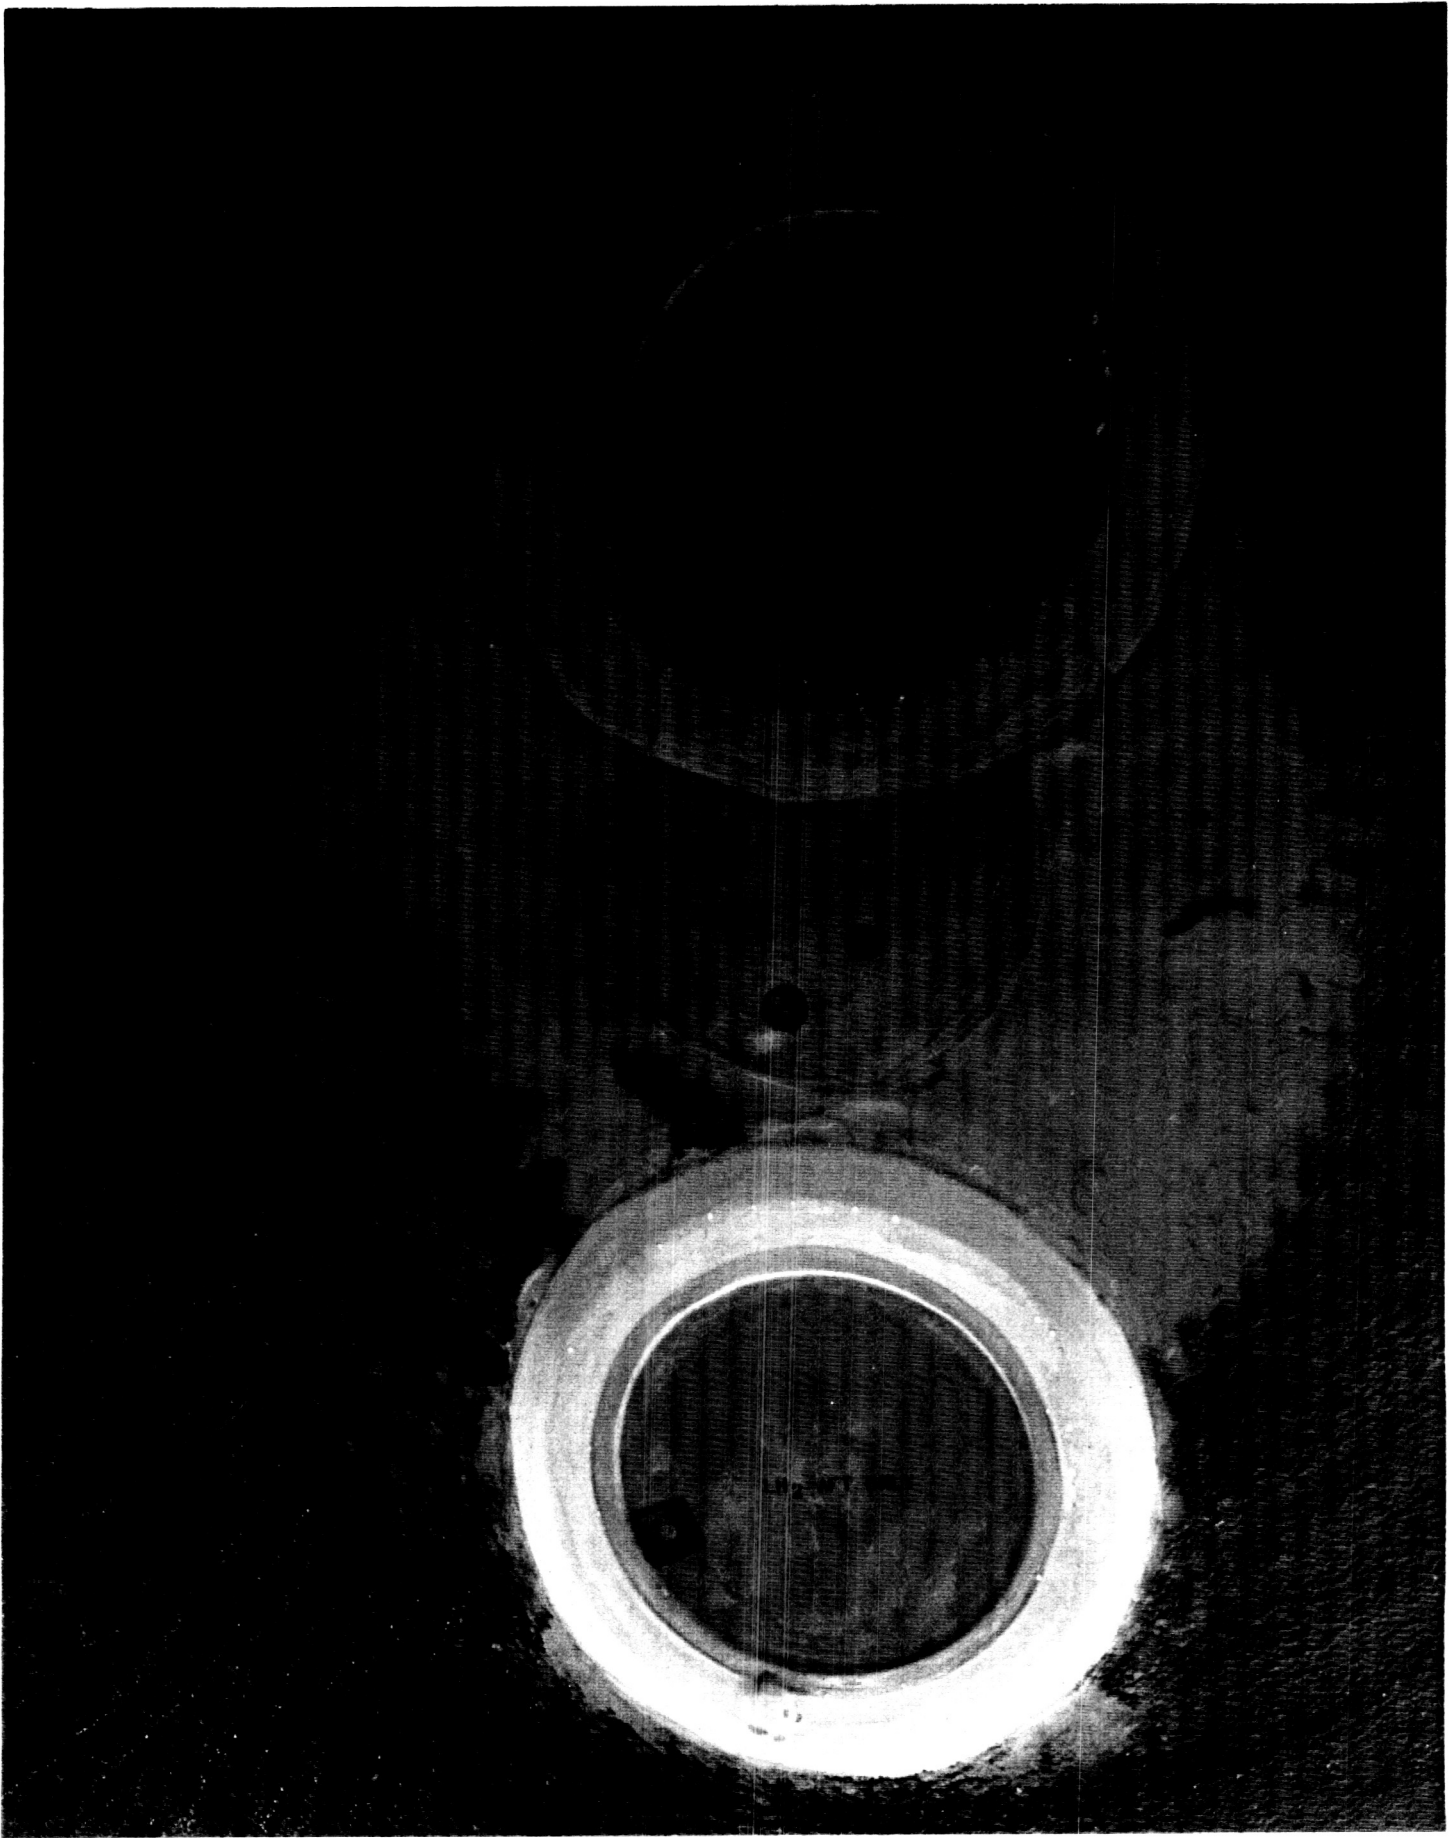
Light frost spots on the ET LH2 tank aft dome apex and
manhole cover, which are acceptable per NSTS-08303

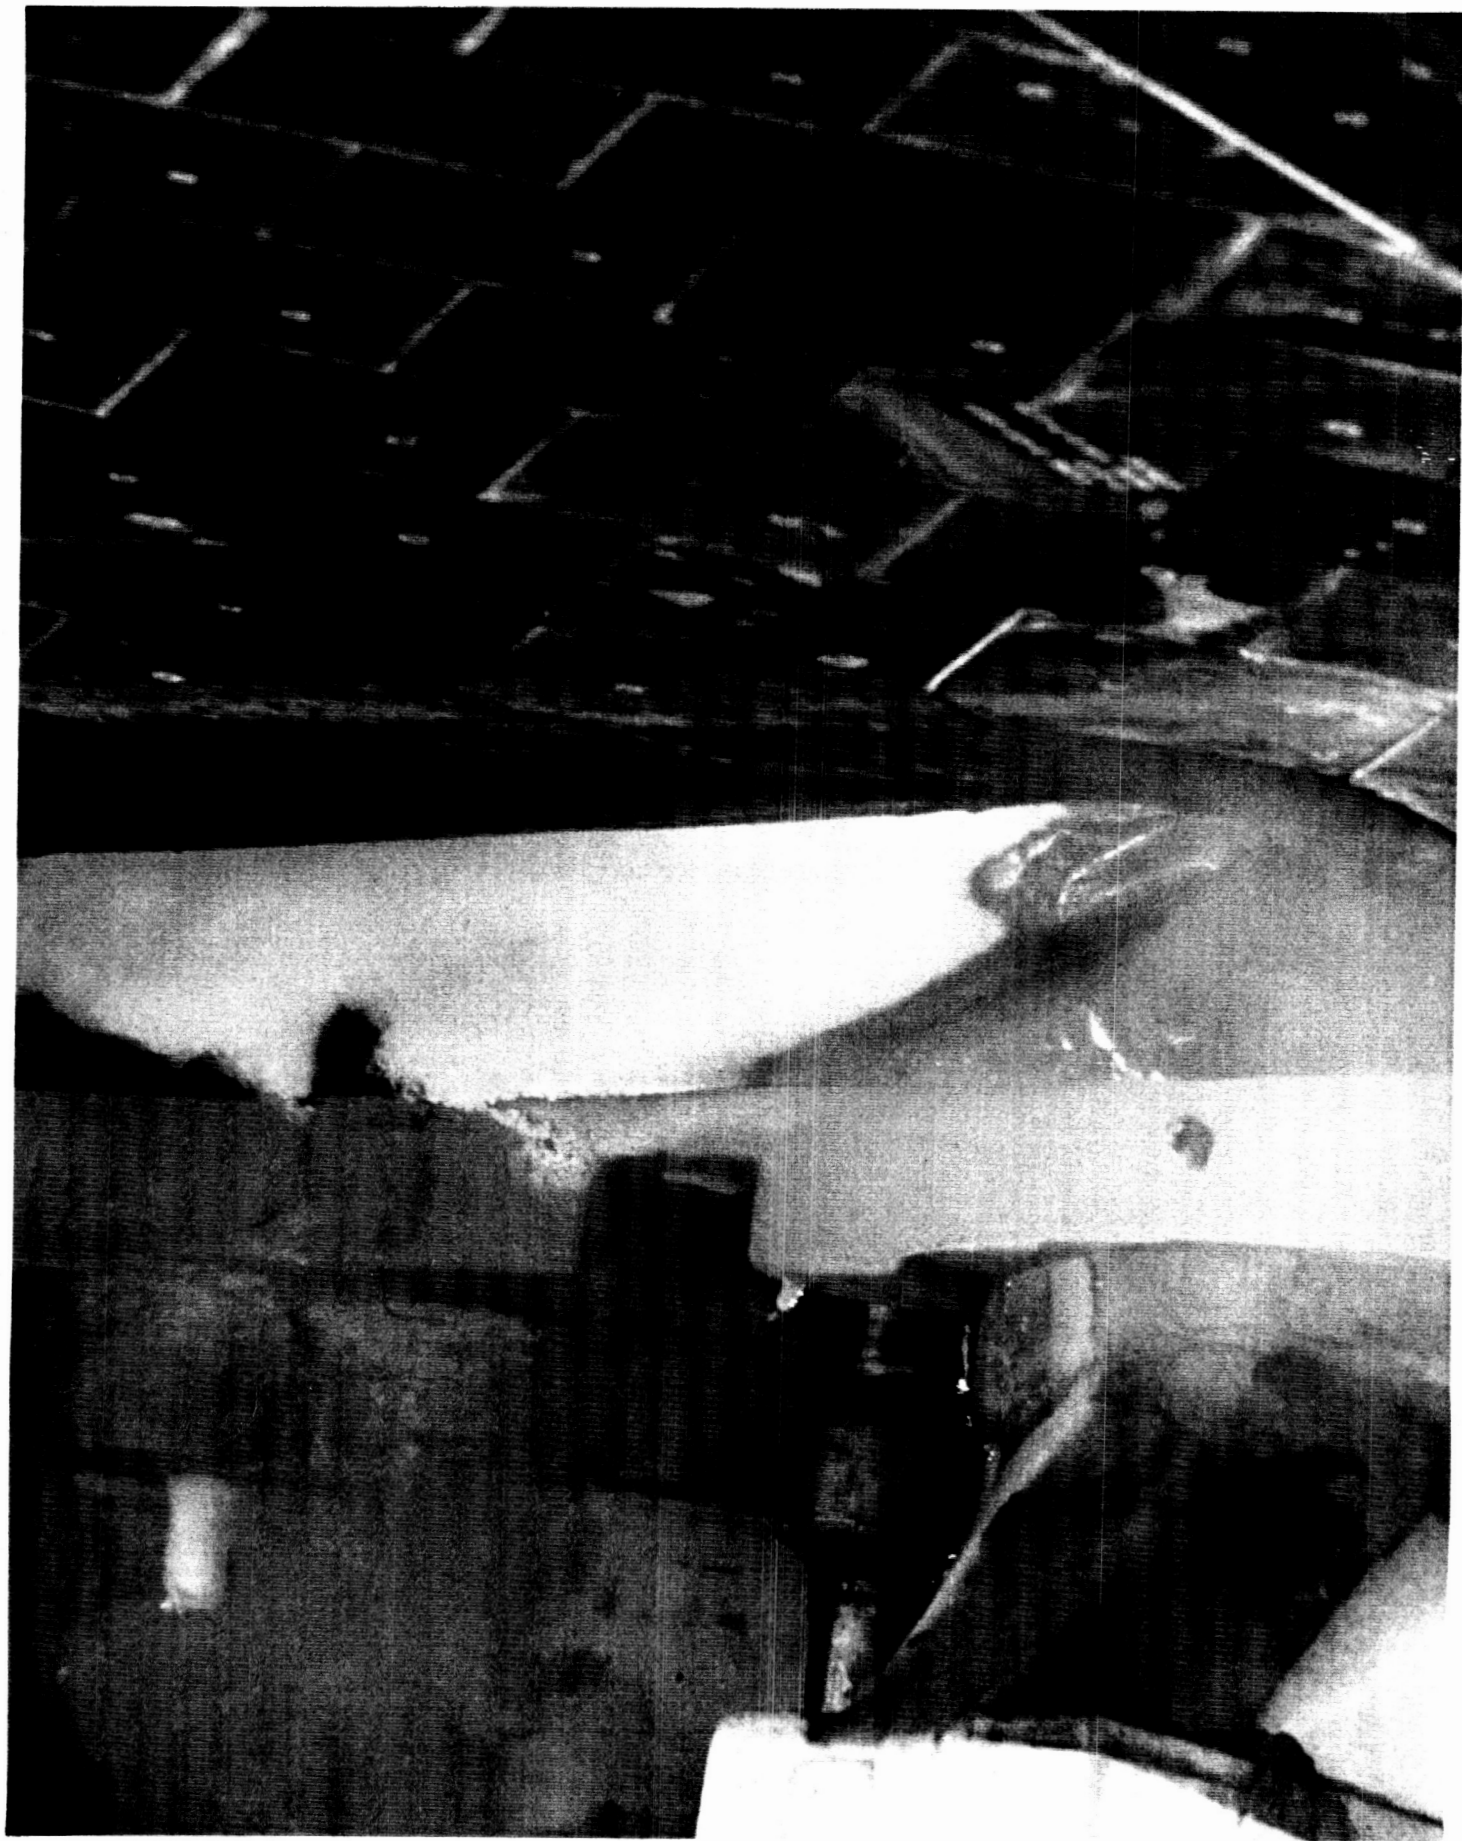
The sides of the ET/ORB LH2 umbilical were covered by moderate, but typical, ice/frost. A frost finger formed on the purge vent

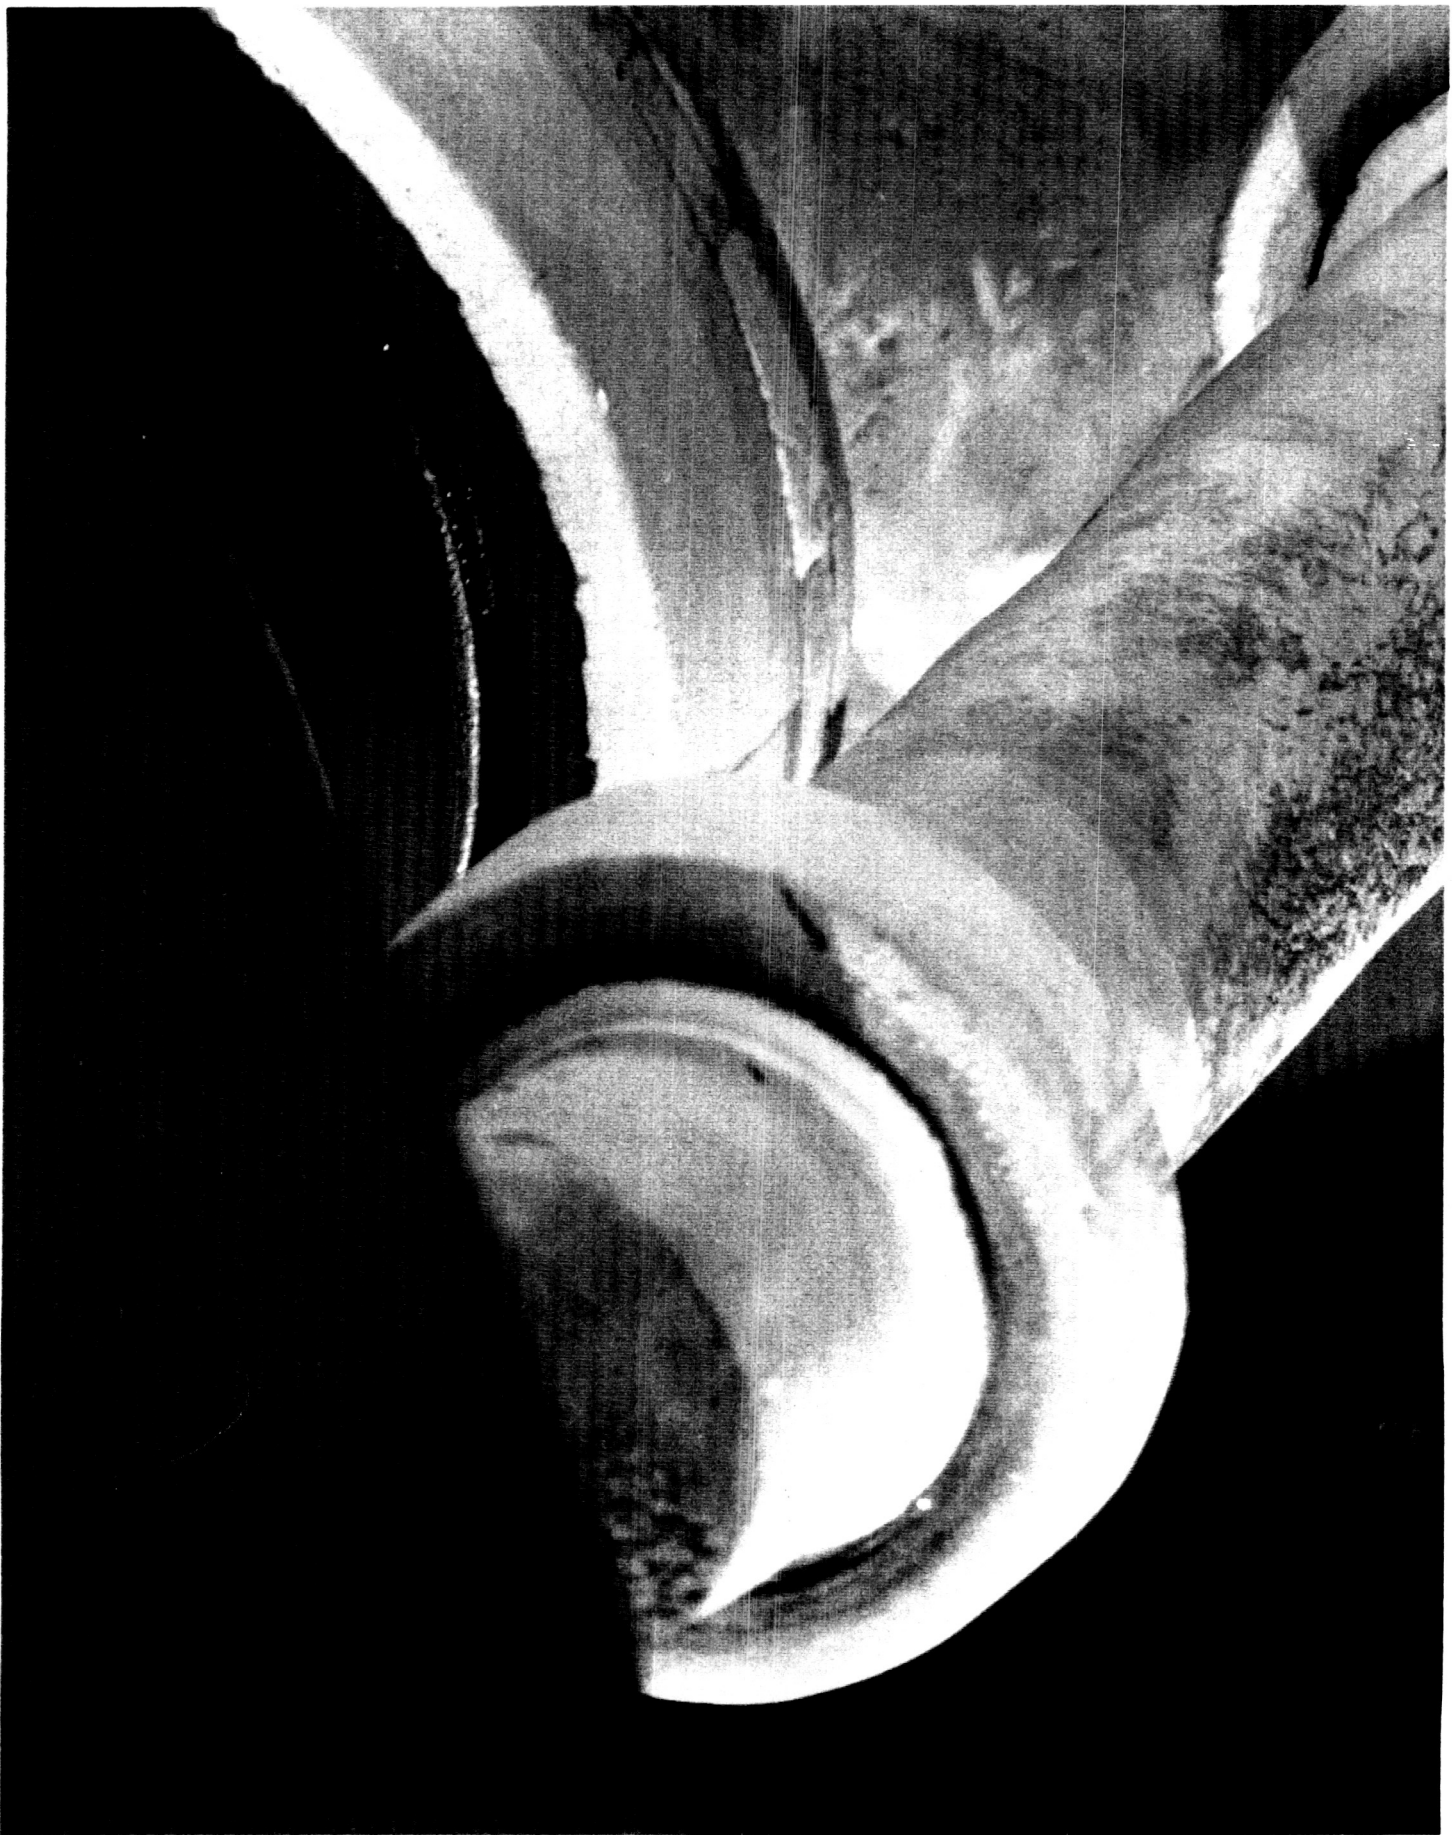
A moderate amount of ice had formed in the LH2 recirculation line bellows, but only condensate appeared in feedline bellows.

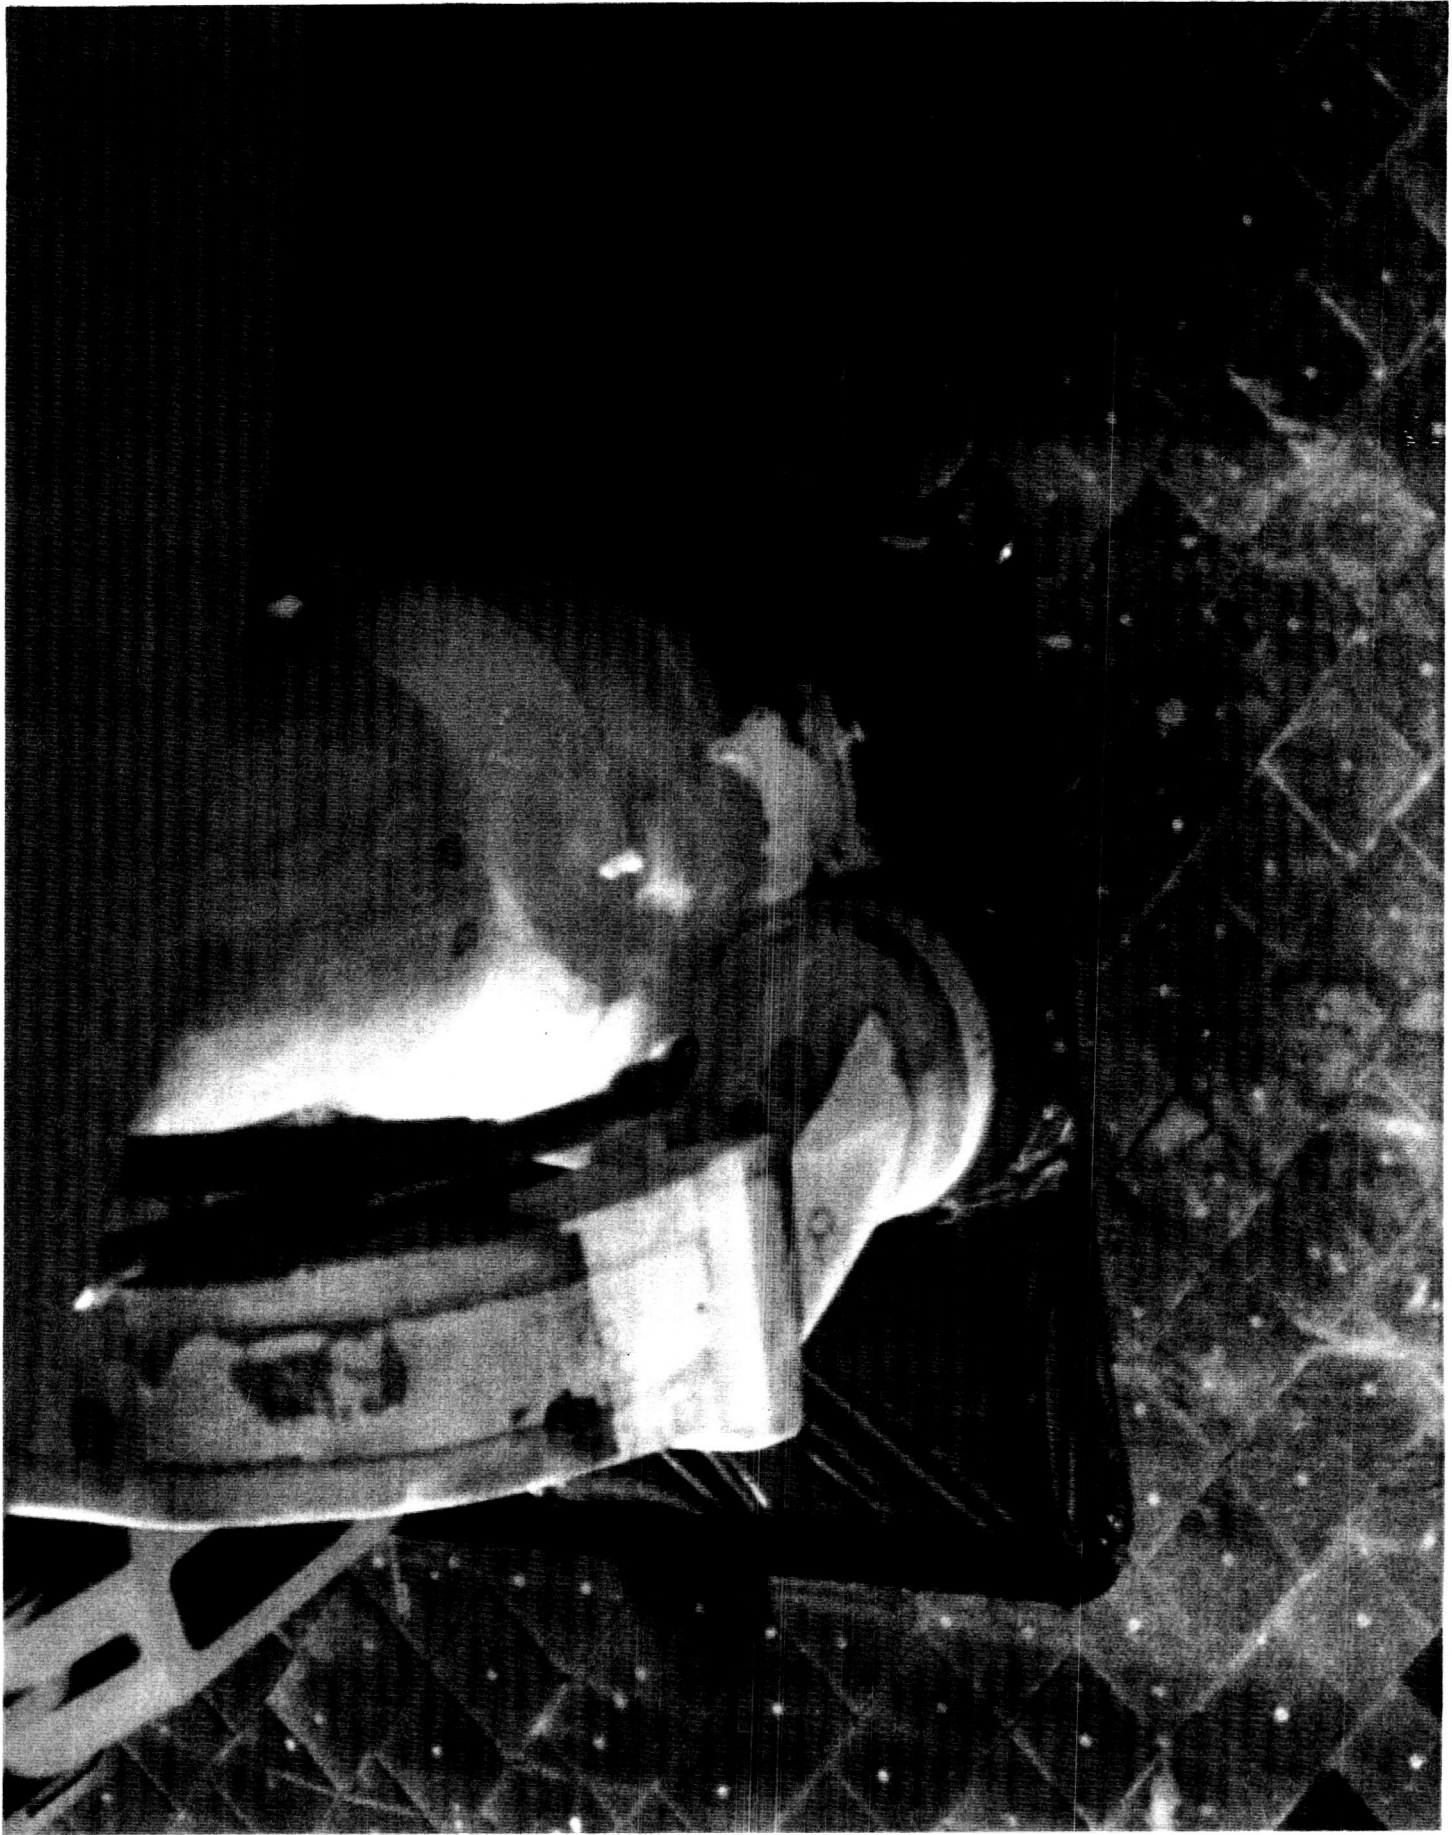
Light, but typical, ice/frost formed on the aft side of the ET/ORB LO2 umbilical. Frost fingers formed on the purge vents.

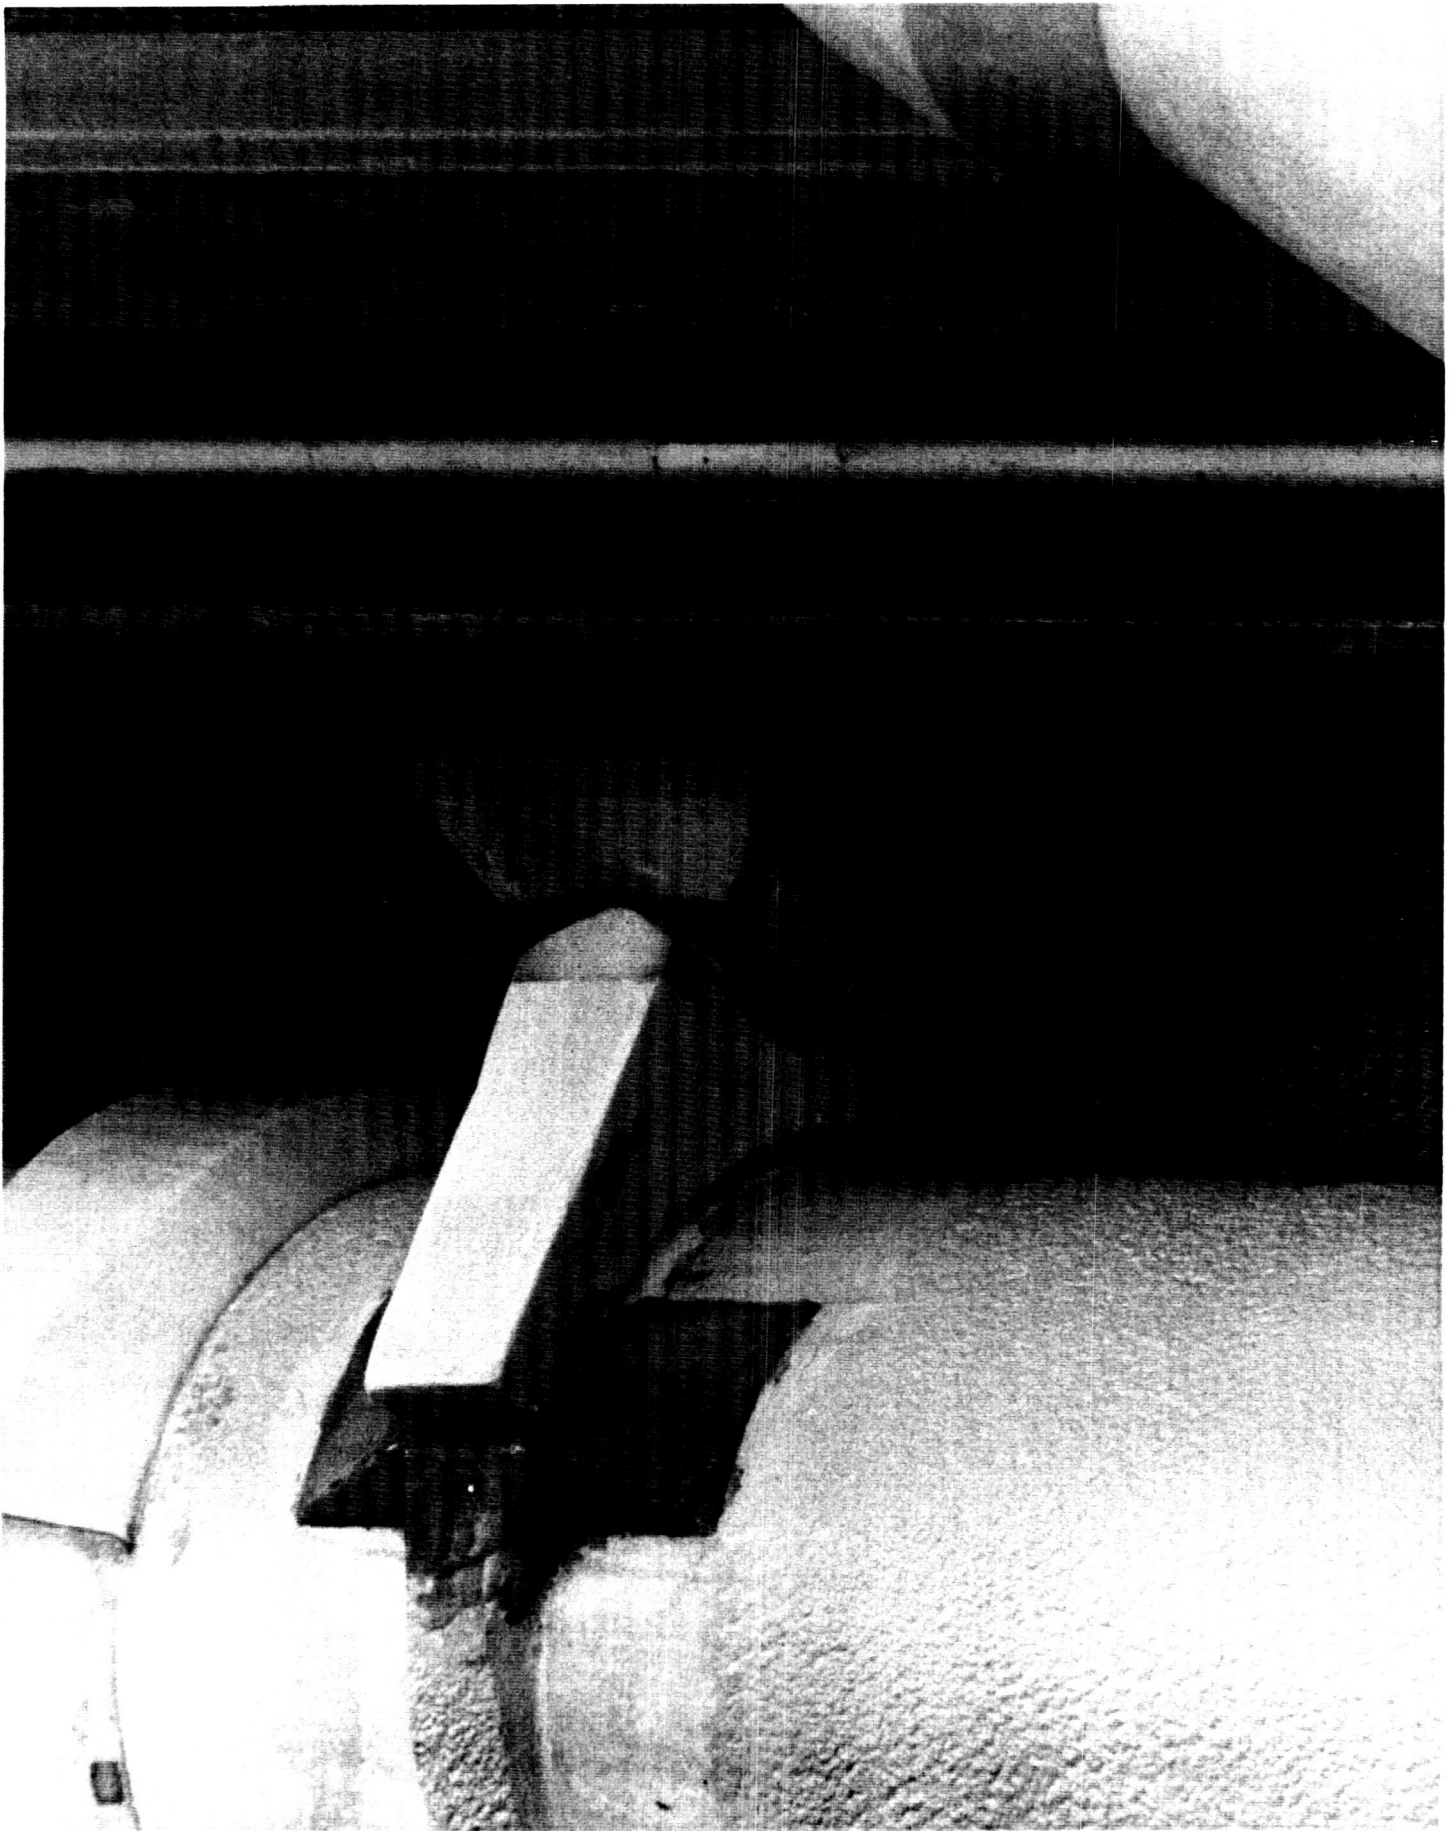
Typical formation of ice/frost in the LO2 feedline
support brackets

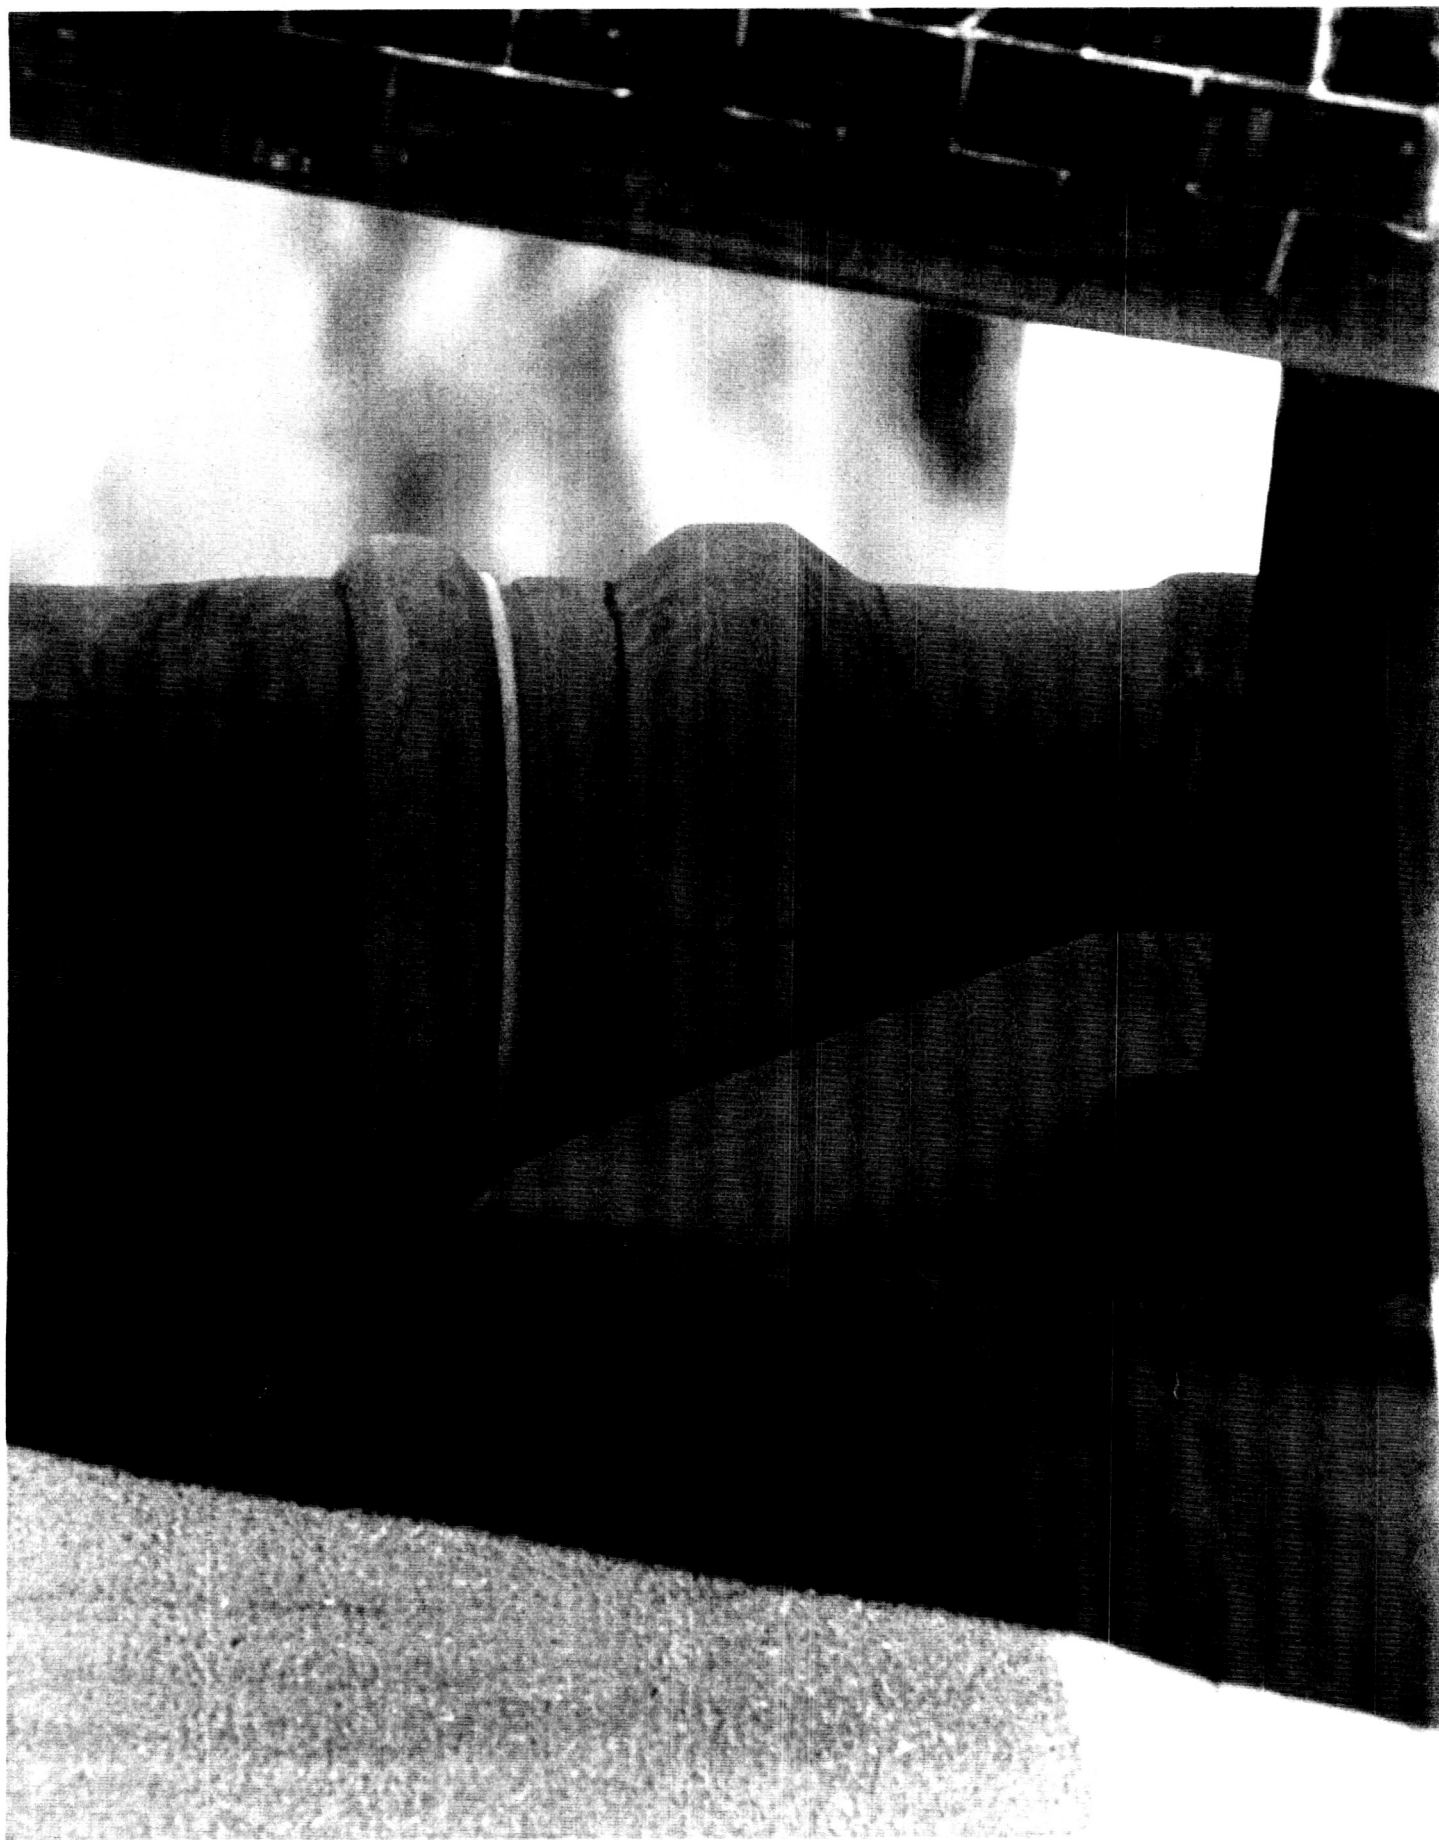
Hard ice and frost had accumulated in the upper LO2
feedline bellows

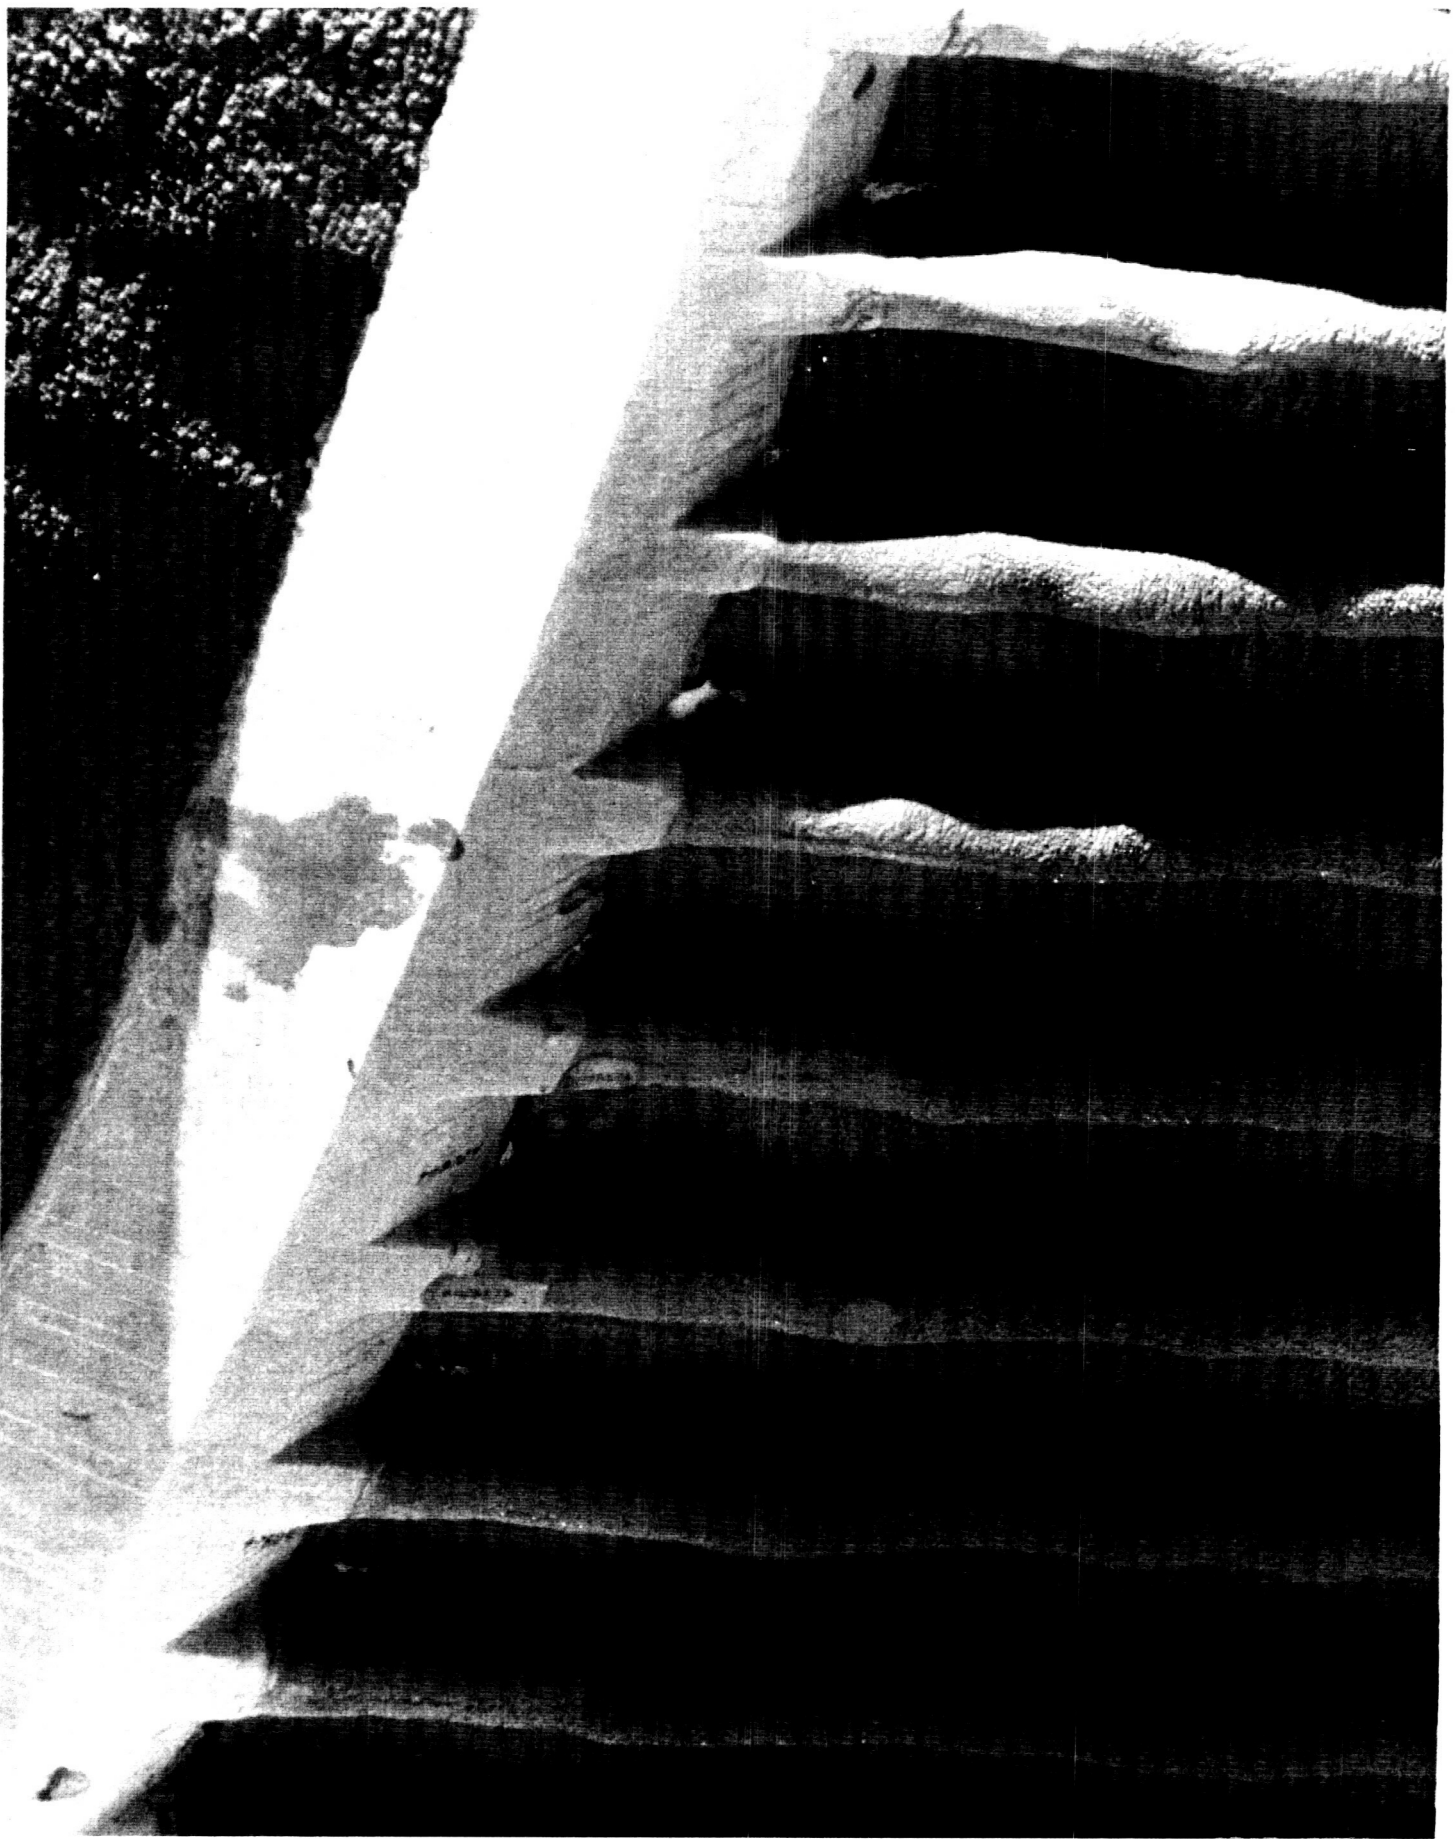
Ice had formed in the -Y-Z stringer valleys at the
LH2 tank and LO2 tank-to-intertank flanges
